NASA TM X-55281

**FLIGHT REPORT  
INTERPLANETARY MONITORING PLATFORM  
IMP II - EXPLORER XXI**

**AUGUST 1965**

**GODDARD SPACE FLIGHT CENTER  
GREENBELT, MARYLAND**

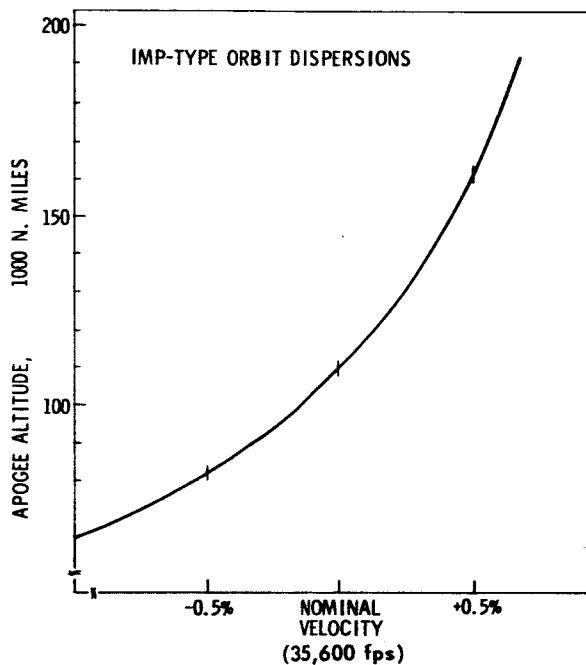
Figure 2

The effective velocity increment imparted by the third stage was 5 to 6 per cent below nominal, which caused the total injection velocity to be about 1.8% low. For an IMP mission (i.e., high orbit eccentricity), a small change in injection velocity causes a large change in apogee height (Figure 2).

The difference in the velocity increment noted above was due to reduced performance and thrust misalignment occurring about 17 seconds after ignition. Tracking data indicated a decrease in acceleration after 16 seconds of normal burning until burnout, which was two seconds longer than predicted. At burnout, automatic gain control (AGC) data indicated that the third stage and spacecraft were coning (Reference 6).

The decrease of acceleration (or thrust) and the longer burn time suggest a decrease of chamber pressure. This, combined with the observed coning motion and some ground test data, lead to the hypotheses that a portion(s) of the igniter assembly broke under the stresses of acceleration and vibration and was ejected through the throat causing an unsymmetrical increase in throat area (Reference 6).

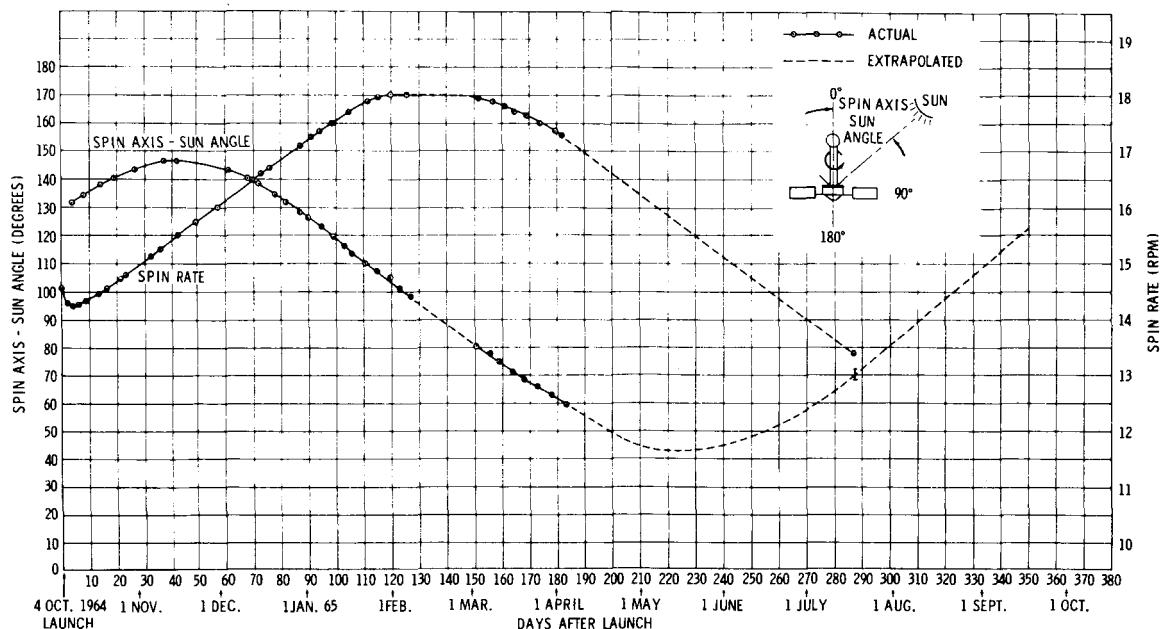
Figure 3

Following separation of the spacecraft from the third stage, the coning motion of the spacecraft damped out and the observed spin rate decreased to 14.25 rpm (four and one-half days after launch). The spin rate subsequently increased due to solar radiation pressure when the incident sunlight was below the spacecraft equator and decreased when the sun was above the equator (Figure 3).

The spin axis/sun angle (Figure 3) was about  $130^{\circ}$  some eight hours after launch (nominal was  $105^{\circ}$ ) and progressing further from the spacecraft equator, ultimately reaching a maximum value of  $147^{\circ}$  (nominal for the specified launch time was  $135^{\circ}$ ).

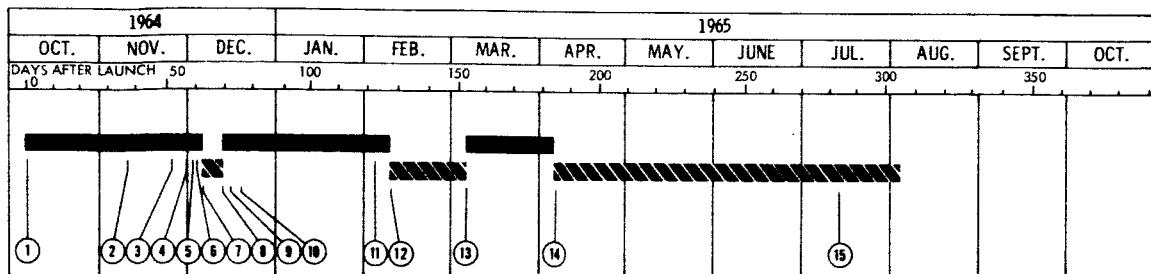
Figure 4

In addition to a low apogee, the launch malfunction indirectly caused the failure of the spacecraft battery. Symptoms of the failure began to appear some 57 days after launch as the Battery proved incapable of sustaining spacecraft operation within the shadow of the earth. By 63 days after launch, the Battery had failed completely (but in a "fail safe" mode). Thereafter, the spacecraft would operate (Figure 4 and Appendix A) only during periods of favorable incident sun angles. (However, each time the spacecraft entered a shadow, it would turn off for the (nominal) 8-hour recycle period.)

- ① 4 OCTOBER 1964 - LAUNCH (EXPLORER XXI, DELTA 26).
- ② & ③ UNDER-VOLTAGE TURN-OFFS DUE TO POOR SUN-ANGLE.
- ④-⑥ UNDER-VOLTAGE TURN-OFFS WHILE IN EARTH'S SHADOW.
- ⑦ 5 DECEMBER THRU 12 DECEMBER - INTERMITTENT OPERATION DUE TO FAILURE OF S/C BATTERY CAUSED BY EXCESSIVE TEMPERATURE.
- ⑧ 13 DECEMBER - SATISFACTORY OPERATION RE-

- SUMED AS SUN-ANGLE REACHED A FAVORABLE POSITION.
- ⑨ 13-18 DECEMBER - UNDER-VOLTAGE TURN OFFS (4) EACH TIME THE S/C ENTERED THE EARTH'S SHADOW AT PERIGEE.
- ⑩ 18 DECEMBER - S/C ENTERS 100% SUNLIGHT ORBIT.
- ⑪ 4 FEBRUARY 1965 - S/C TELEMETRY SPURIOUSLY COMMANDED OFF; 23 1/2 HOURS OF DATA LOST BEFORE TELEMETRY WAS COMMANDED ON.

- ⑫ 9 FEBRUARY - INTERMITTENT OPERATION RE-SUMED AS SUN-ANGLE BECAME UNFAVORABLE; DURATION OF "ON" PERIODS WERE LESS THAN 5 MINUTES UNTIL 3 MARCH.
- ⑬ 5 MARCH - SAME AS ⑧ ABOVE.
- ⑭ 5 APRIL - INTERMITTENT OPERATION RESUMED AS SUN-ANGLE BECAME UNFAVORABLE.
- ⑮ MID-JULY - SOME PERIODS OF OPERATION AS LONG AS 1/2 HOUR.

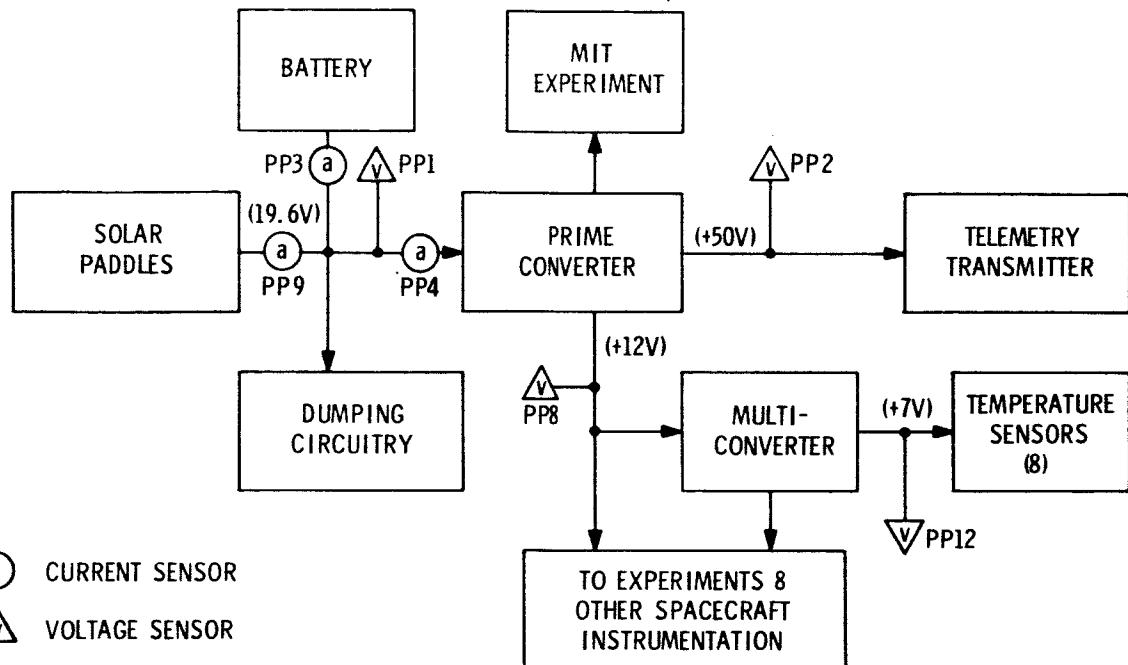
Figure 5

The location of the voltage and current sensors are shown relative to the IMP electrical system in Figure 5. The Placement of thermistors is shown in Figure 6.

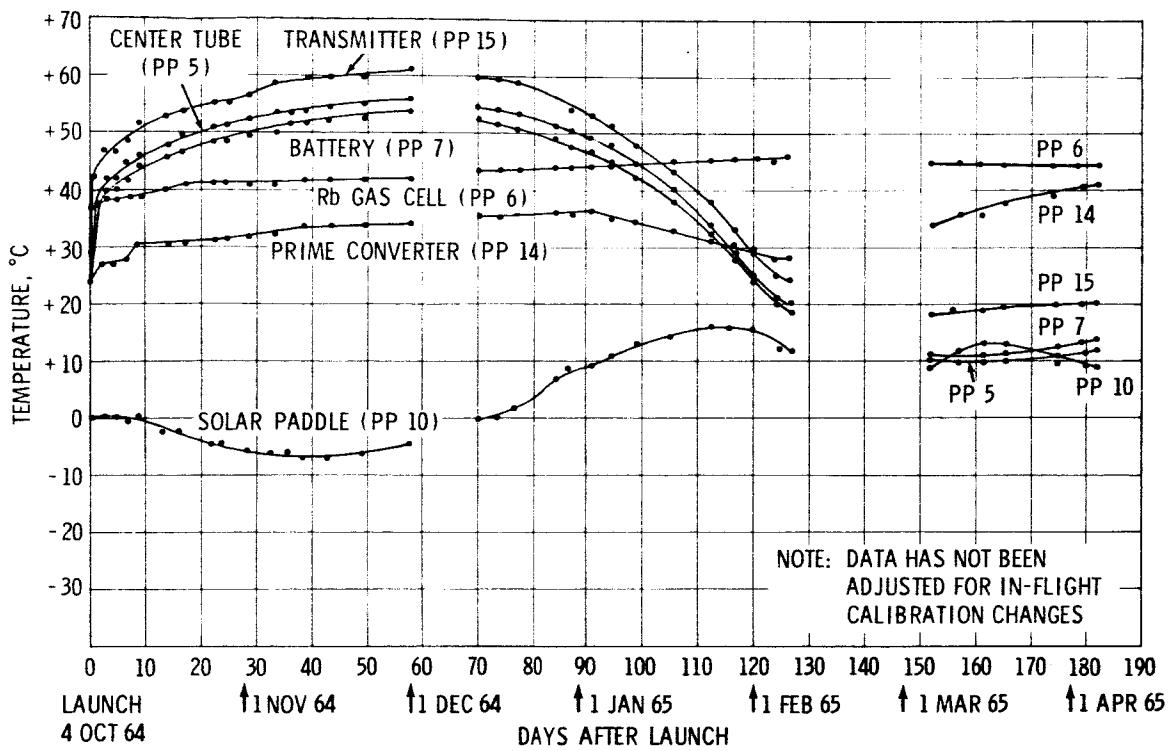
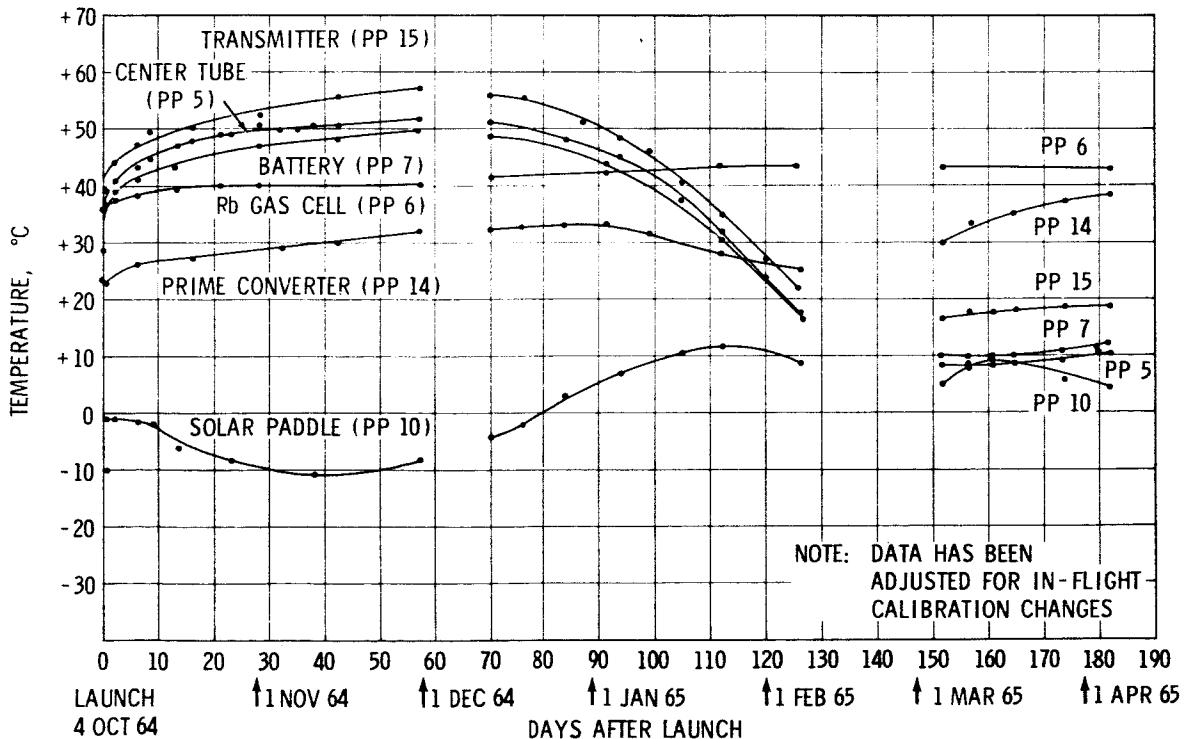
During the periods of operation, most of the temperatures within the octagonal instrument compartment remained in the region of  $+10^{\circ}\text{C}$  to  $+60^{\circ}\text{C}$  (Figures 7 and 8). The transmitter (typically a hot location) reached a maximum temperature of  $+58^{\circ}\text{C}$  about two months after launch; the Battery reached  $+50^{\circ}\text{C}$  at about the same time; and the Prime Converter reached a maximum of  $+39^{\circ}\text{C}$  some six months after launch.

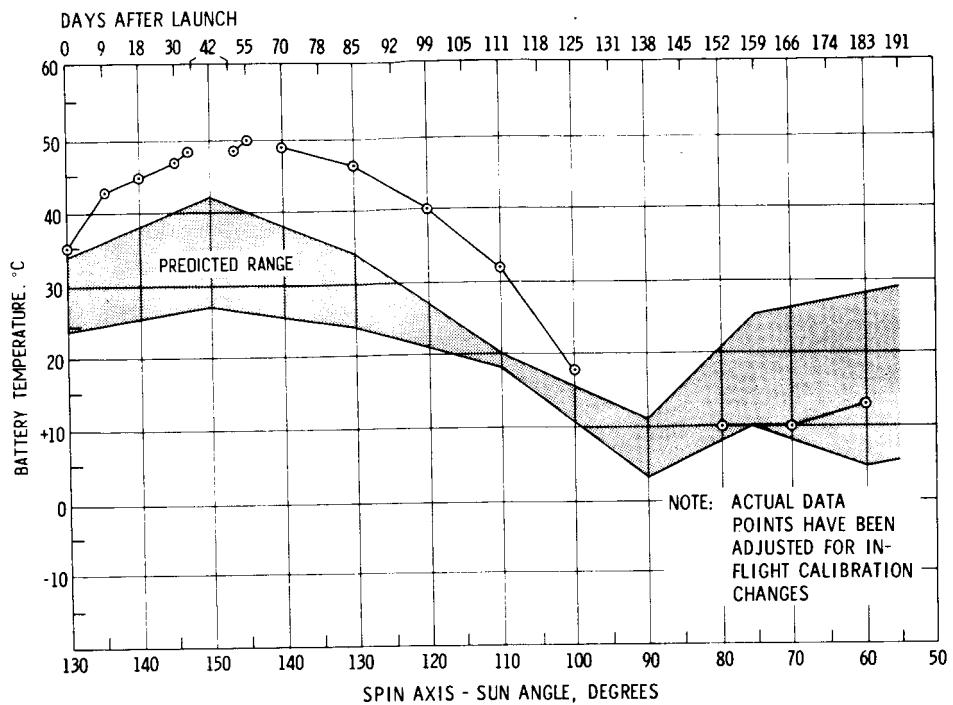
Figure 9

For purposes of comparison, the predicted and actual (adjusted) temperature data for the Battery, Prime Converter, and Transmitter locations are shown in Figures 9, 10, and 11 respectively. In general, the in-flight temperatures exceeded predictions when the sun was shining from below the space-craft equator ( $90^\circ$  to spin axis), while at angles above the equator the actual temperatures were equal to or less than predictions.

The Battery in IMP II failed as a result of the excessive temperature environment to which it was subjected. There were two reasons which account for the fact that the Battery temperature got too hot (+50°C at 55 days after launch).

- The "tip-off" or perturbation of the spin-axis incurred during the launch phase caused the spin axis/sun angle to progress to about 147°, or about 12° beyond the nominal limit. This region is the warmest for the battery.
- Although sun angles over 135° were beyond the nominal limit for the launch trajectory and time, the thermal-control design limit for IMP was set at 150°. The thermal control failed to maintain the in-flight temperature of the Battery within design limits at angles over 130°.

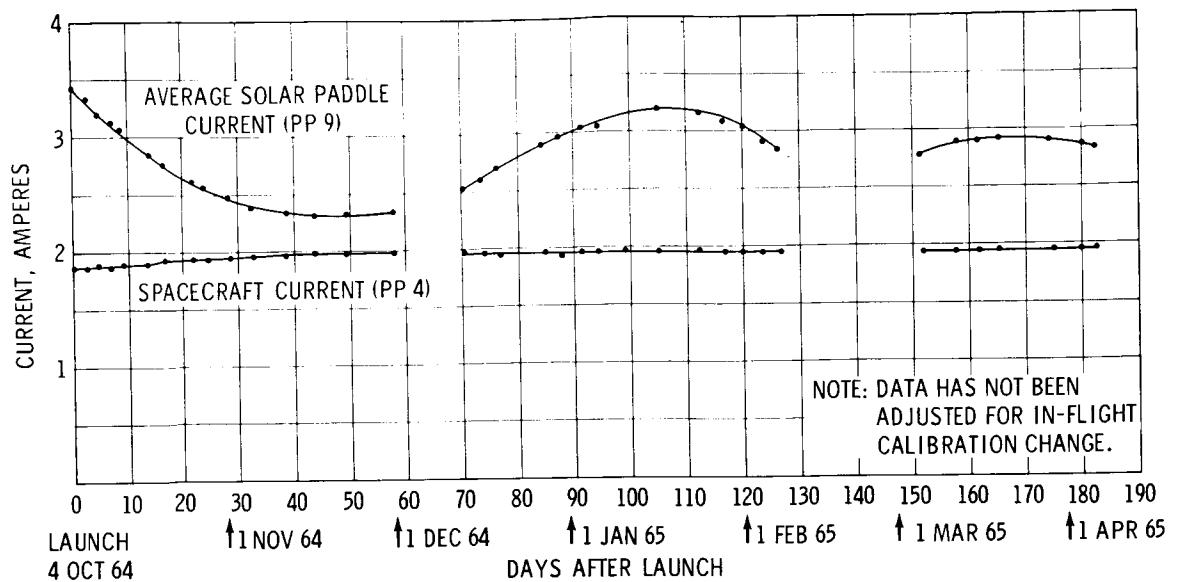
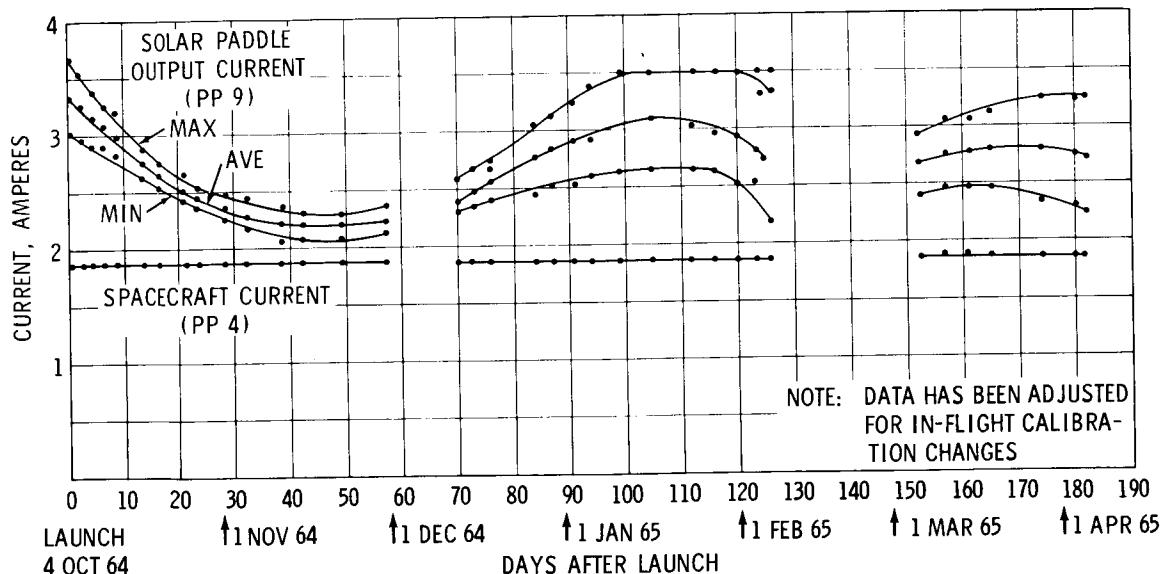
The solar paddle output current and the spacecraft load current are shown as a function of days after launch in Figures 12 and 13.

The variation of paddle output as the satellite spins is shown in Figure 13. For example, at spin axis/sun angles of 140 - 150°, the variation, from lowest output to highest, was 2 1/2 watts. At sun angles of about 100 to 110°, the variation during a spin revolution was over 16.5 watts.

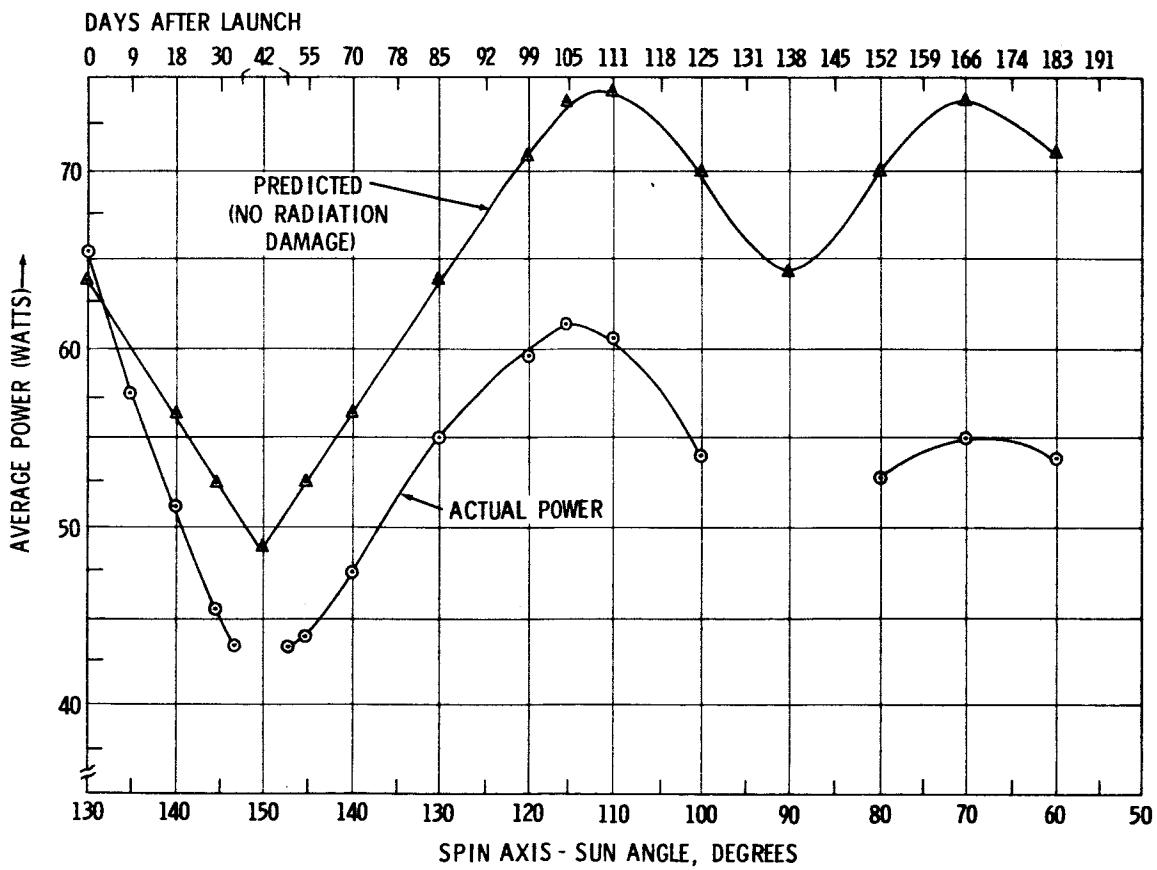
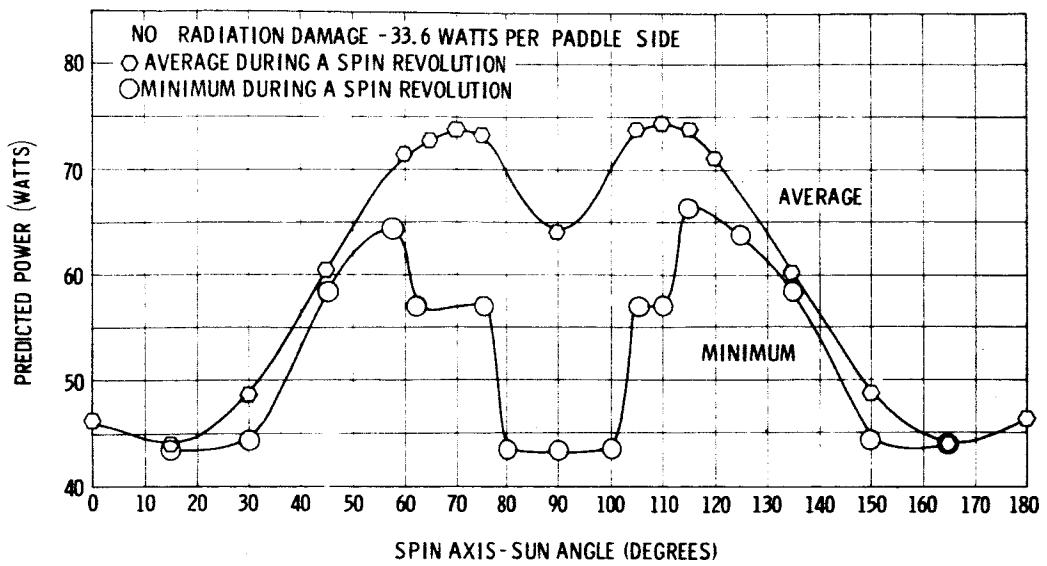
Figure 15

The solar paddles produced an average of 65.8 watts initially, a low of 43.5 watts 6 weeks after launch, and 61.5 watts 3 1/2 months after launch (Figures 14 and 15). Degradation of power output amounted to about 16% after three months in orbit.

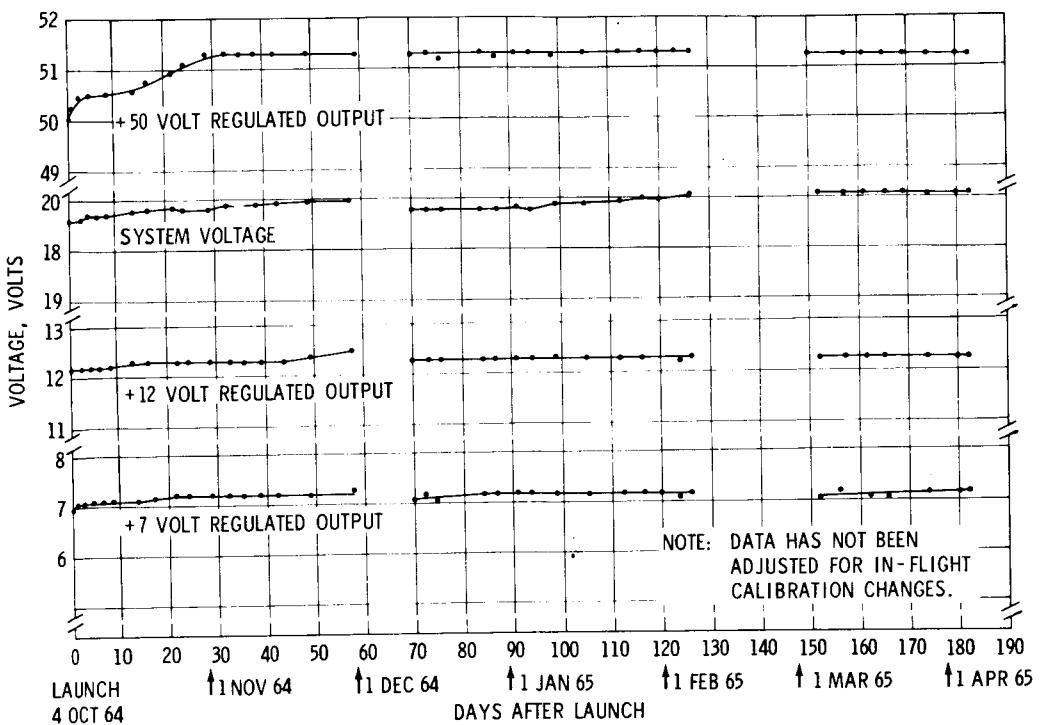
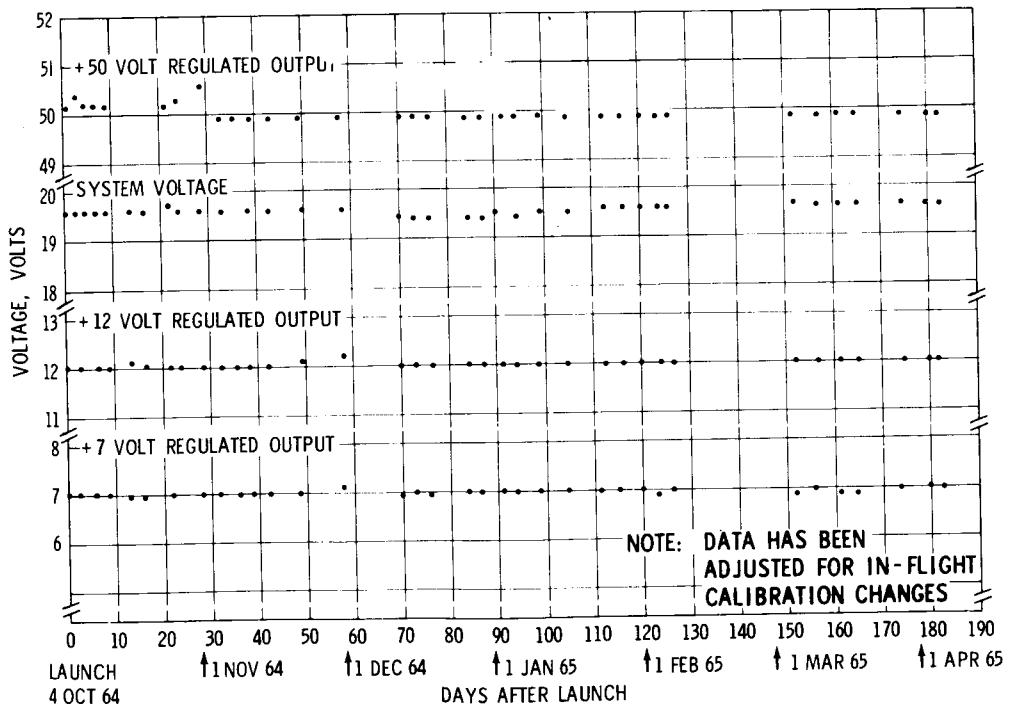
The telemetered (Figure 16) and adjusted (Figure 17) data of the regulated outputs of the Prime and Multi-Converters indicates that these voltages remained within the specified tolerances of  $\pm 1\%$ .
